NATIONAL RESEARCH COUNCIL
CANADA
DIVISION OF BUILDING RESEARCH

TORNADO WIND DAMAGE TO BUILDINGS OBSERVED
AFTER THE SARNIA TORNADO
of May 21, 1953

by
J.D. McCrea
With a Supplement by D.C. Tibbetts

Report No. 111
of the
Division of Building Research

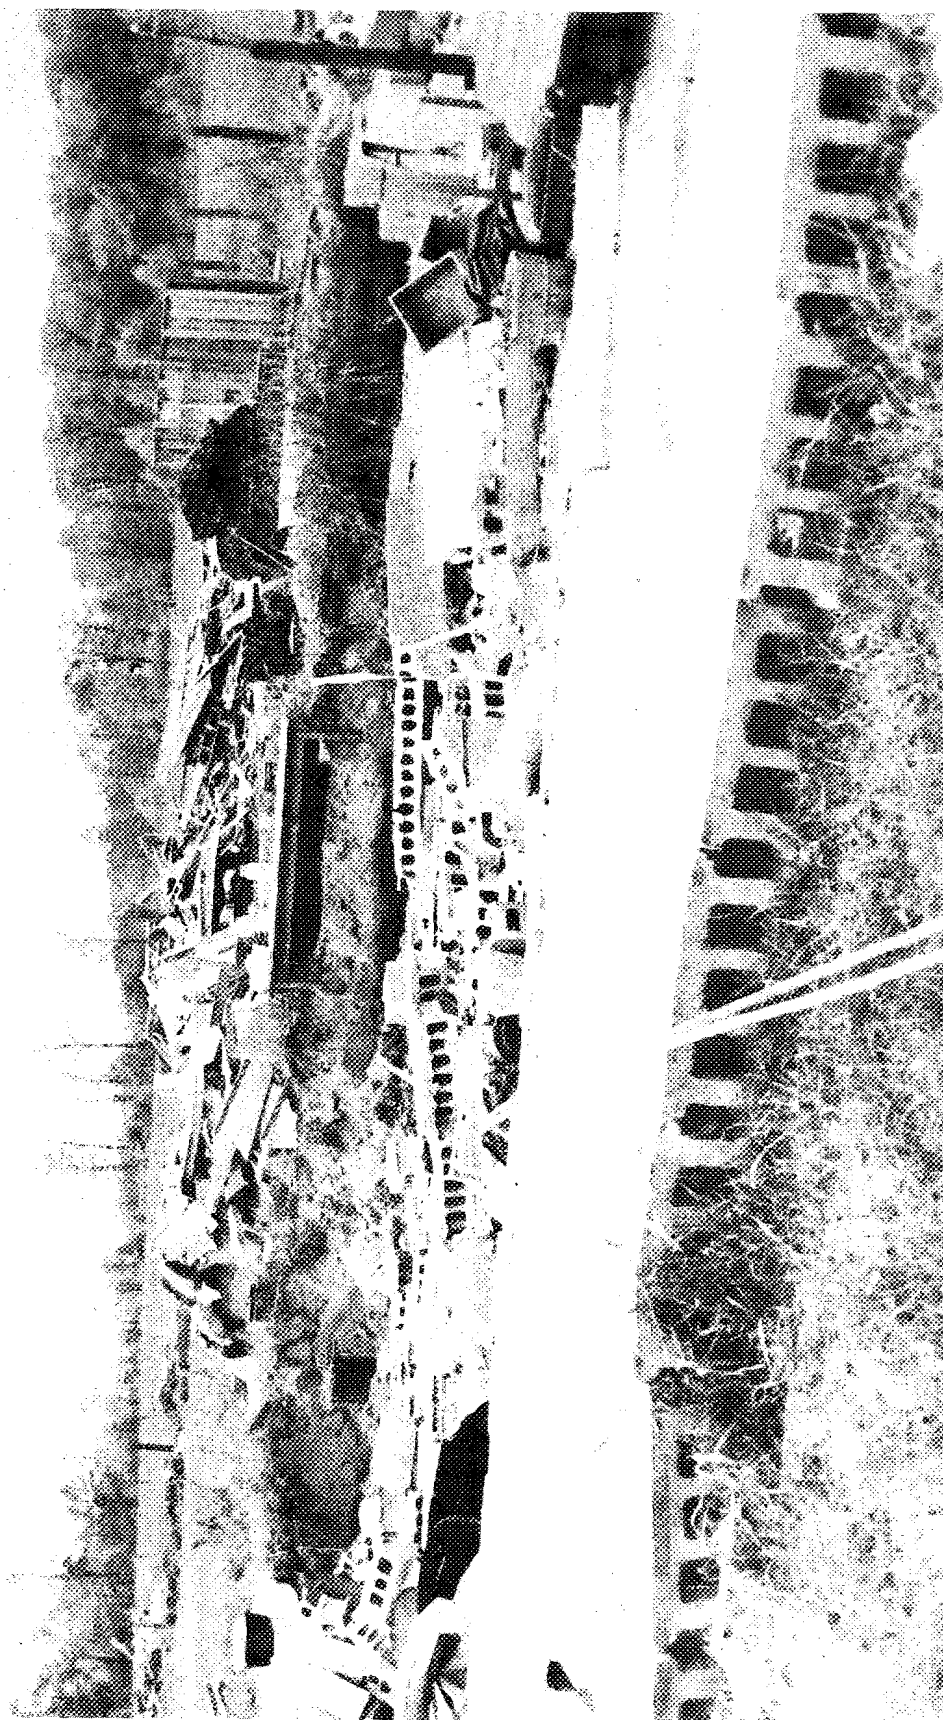
There were not many examples of concrete block construction in the commercial district of Sarnia, but, of the three examples reviewed, two one-storey structures were almost completely demolished. The third, a garage with a hotel occupancy on the second floor, appeared to have been damaged considerably by racking and some of the walls were out of line both laterally and vertically. Since this building had been in disrepair, however, and probably had been altered several times, it was impossible to determine whether the damage had been the result of forces of the tornado.

Figure 3 Completely destroyed concrete block construction

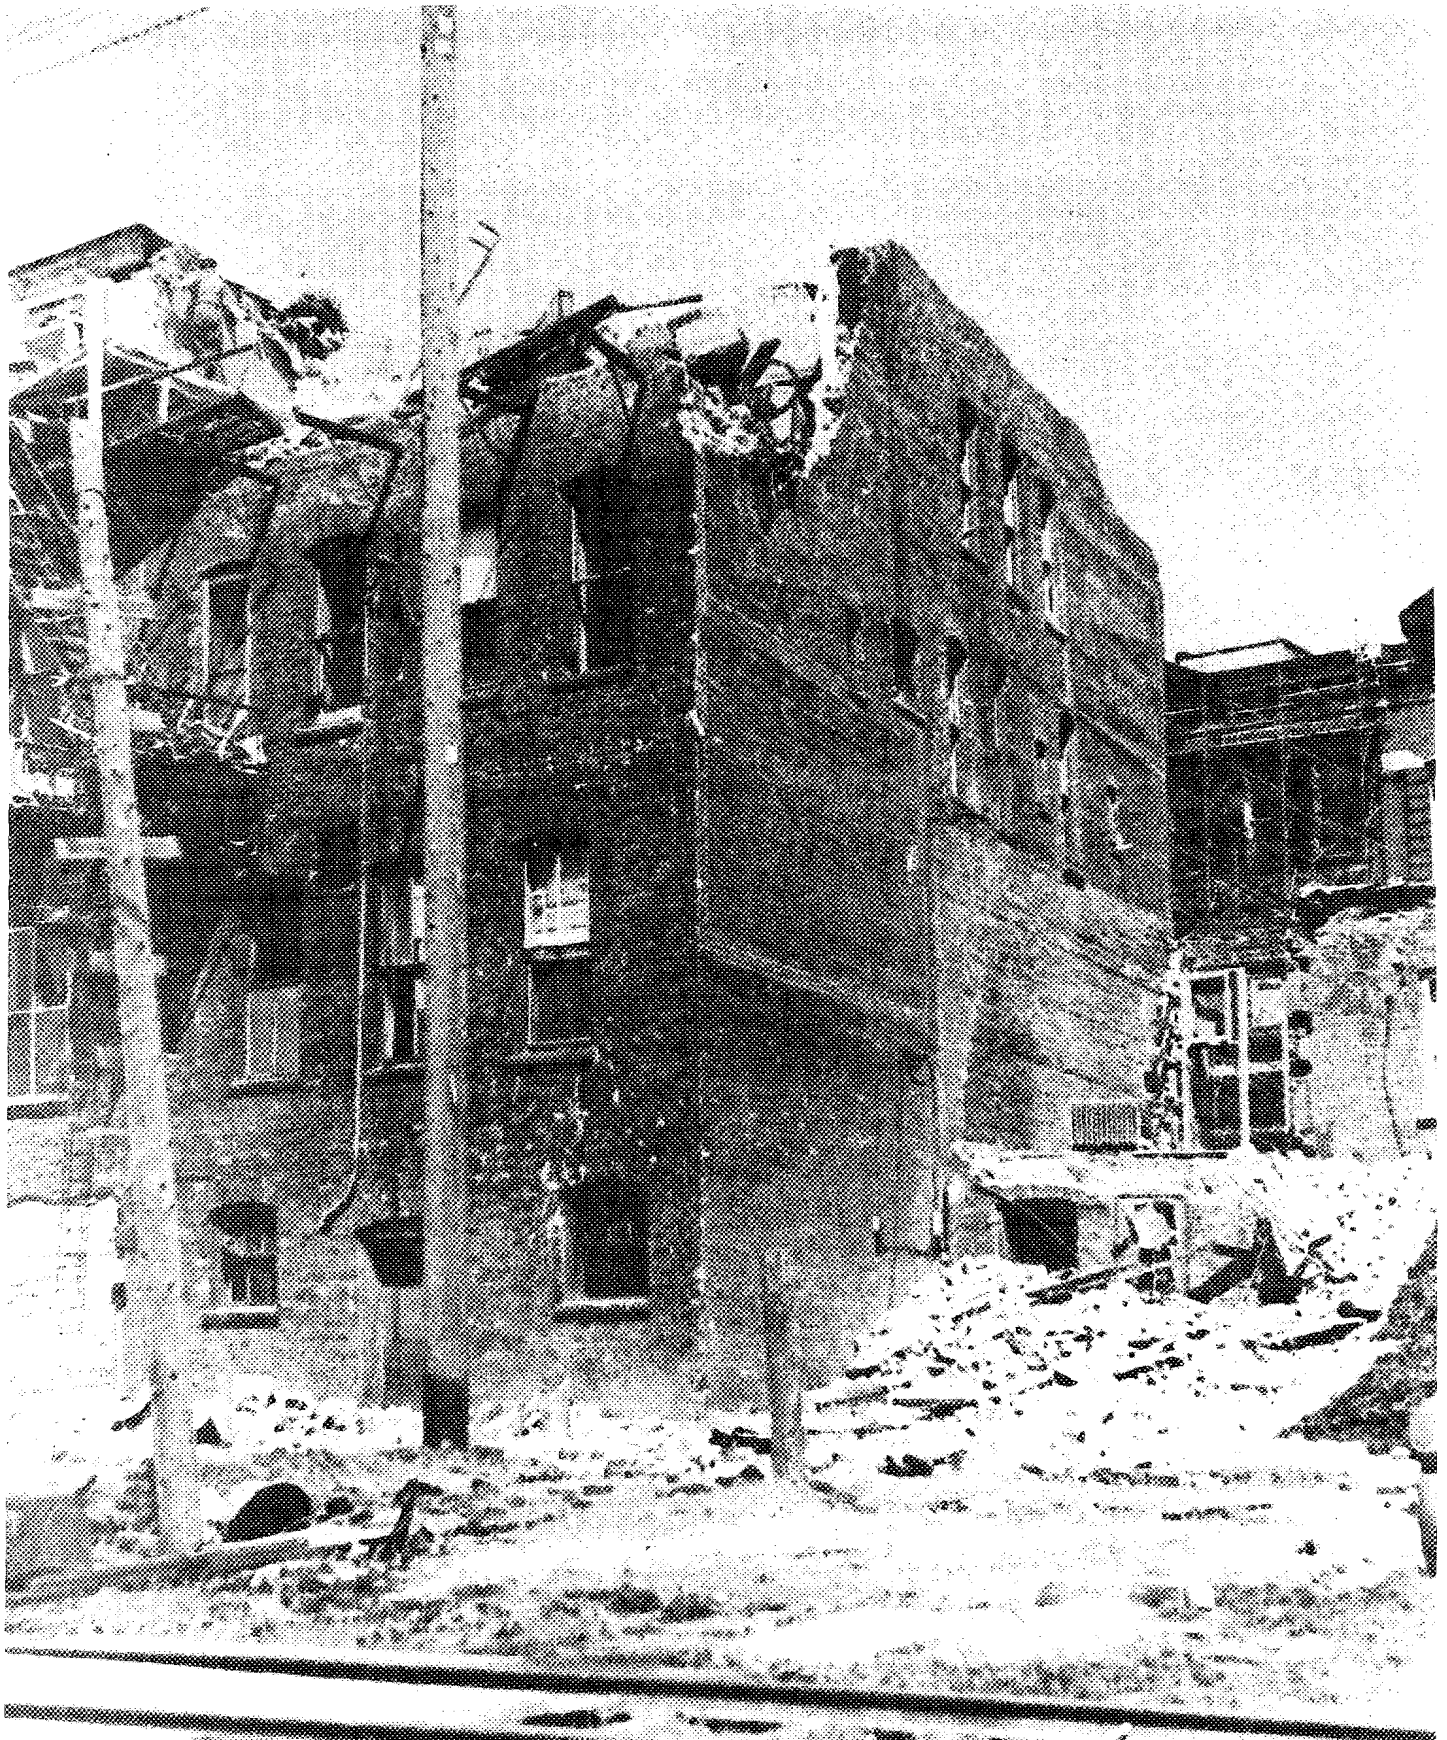
The first buildings in Sarnia to experience the tremendous forces of the storm were of this type of construction along the river front on Front Street. Damage to these consisted of the removal of portions of the complete roof, or the collapse of the top-storey walls (Figs. 4, 5, 6). The Hotel Vendome received considerable damage to its third-and fourth-storey walls. Portions of these walls on the west side (facing the approaching storm) and the fourth-storey wall on the south side were blown out. The large, many-sided tower portion of the building received little damage, indicating the effectiveness of laterally supported or buttressed masonry walls.

- 8,9 Damage to old building of masonry bearing wall type along waterfront (note bicycle still on third floor). (Fig. 4 in DER Report No. 111 - photo 9.)

Figure 4 Damage to old building of masonry bearing wall type
along waterfront (note bicycle still on third floor)

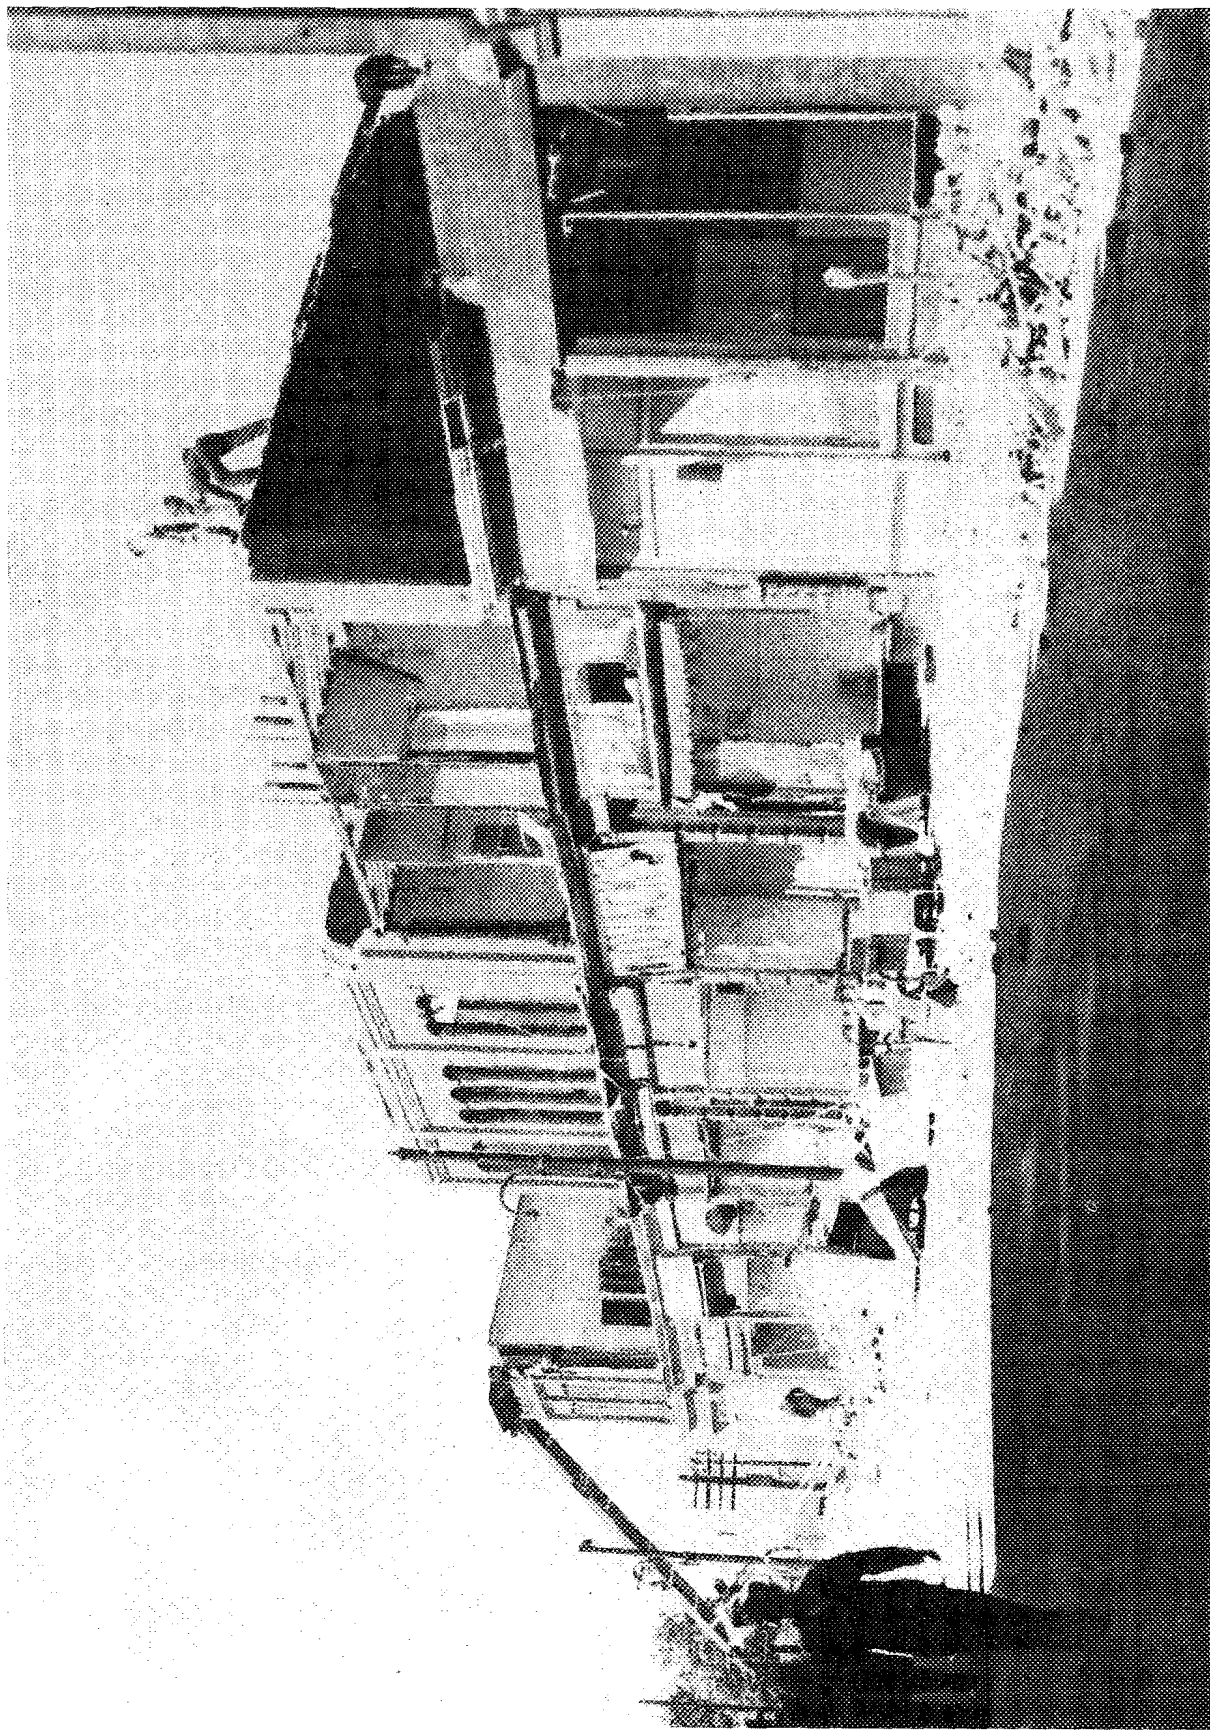
50. View across flat roofs of waterfront buildings
- 51-53 Front Street looking north from Hotel Vendome
54. Corner of Front and Cromwell Streets
55. Front Street. Street cleared, building repairs started (Fig.5 in DBR Report 111)

Figure 5 Front Street. Street cleared, building repairs started

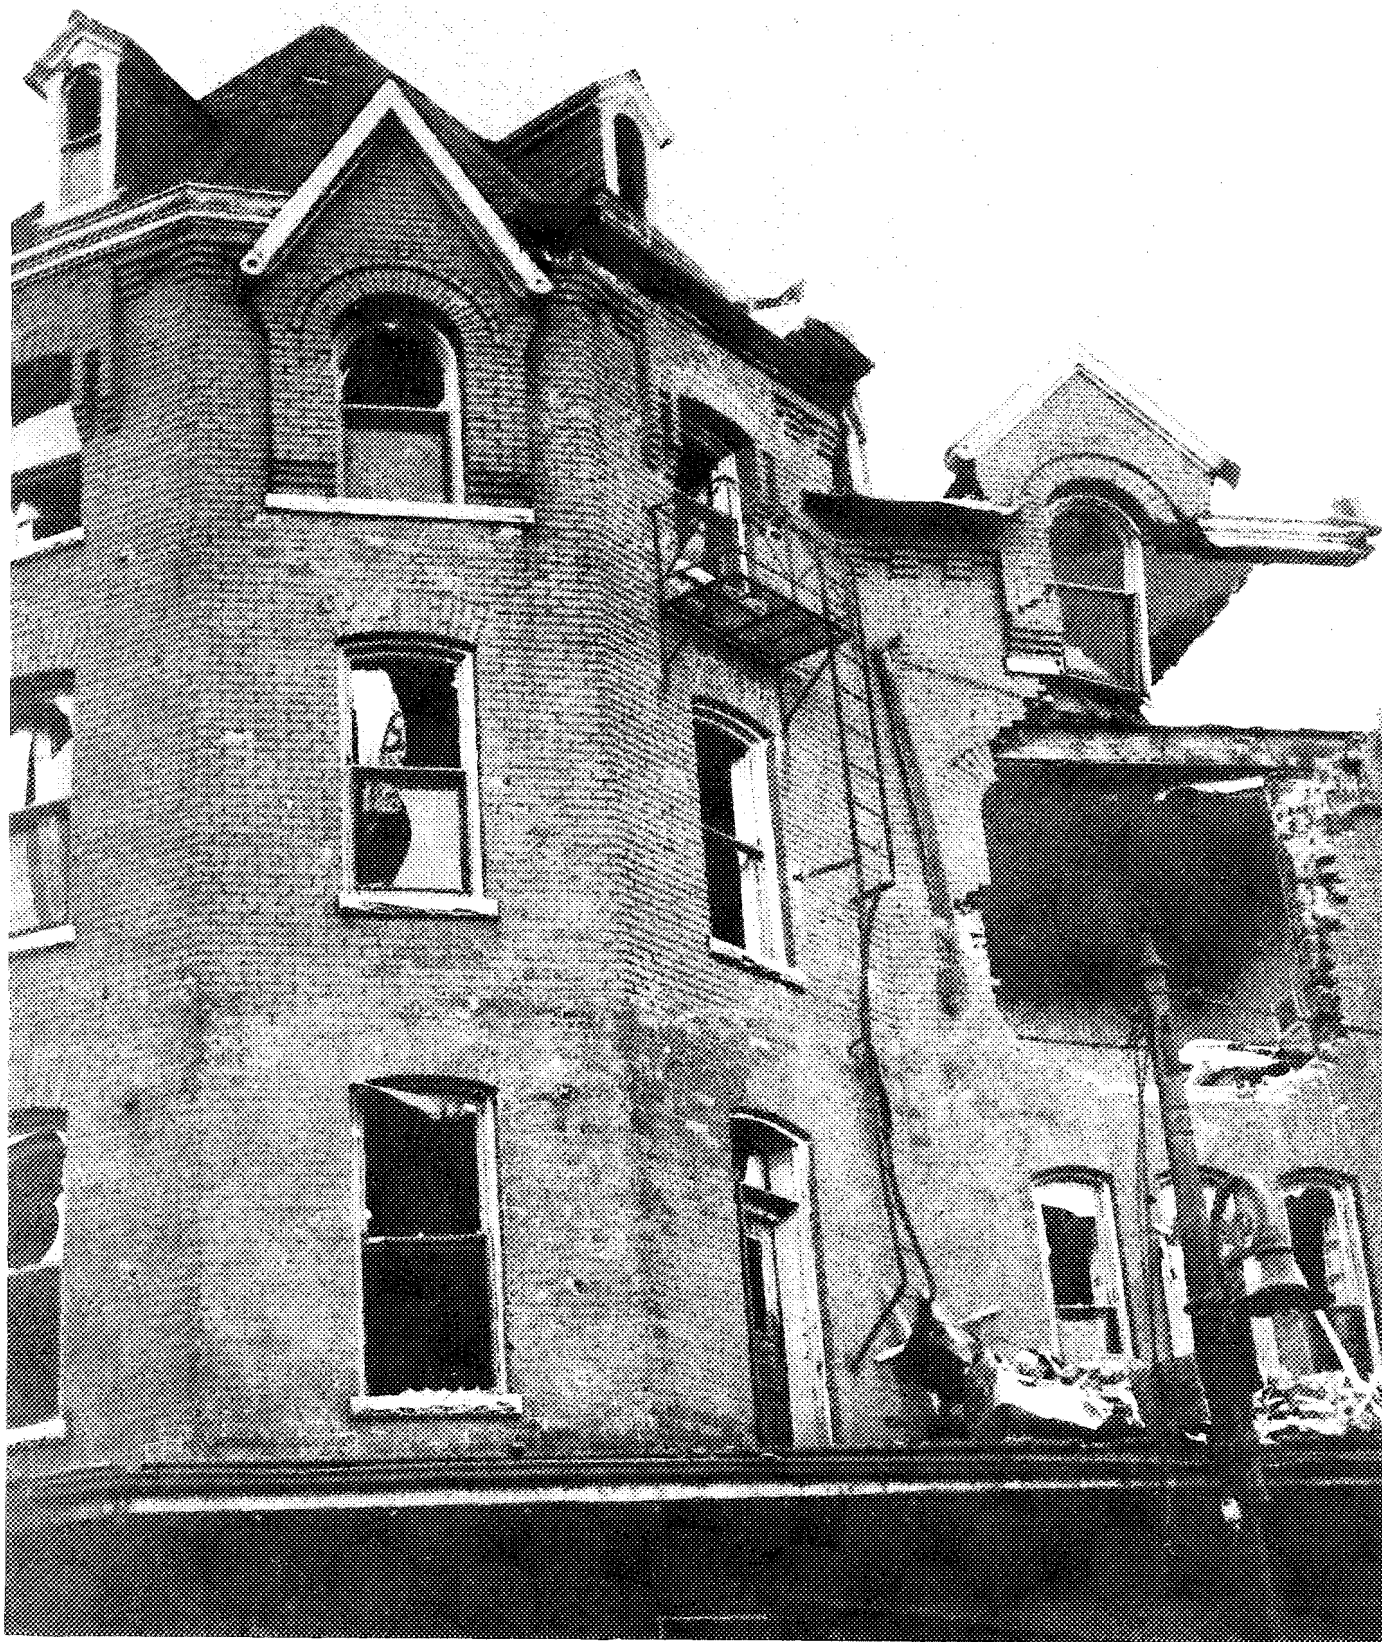
56. Hotel Vendome at the corner of Front and Cromwell Streets. Note absence of damage in braced roof.
- 57,58 Hotel Vendome (Fig.6 in DBR Report 111- photo 58)

Figure 6 Hotel Vendome

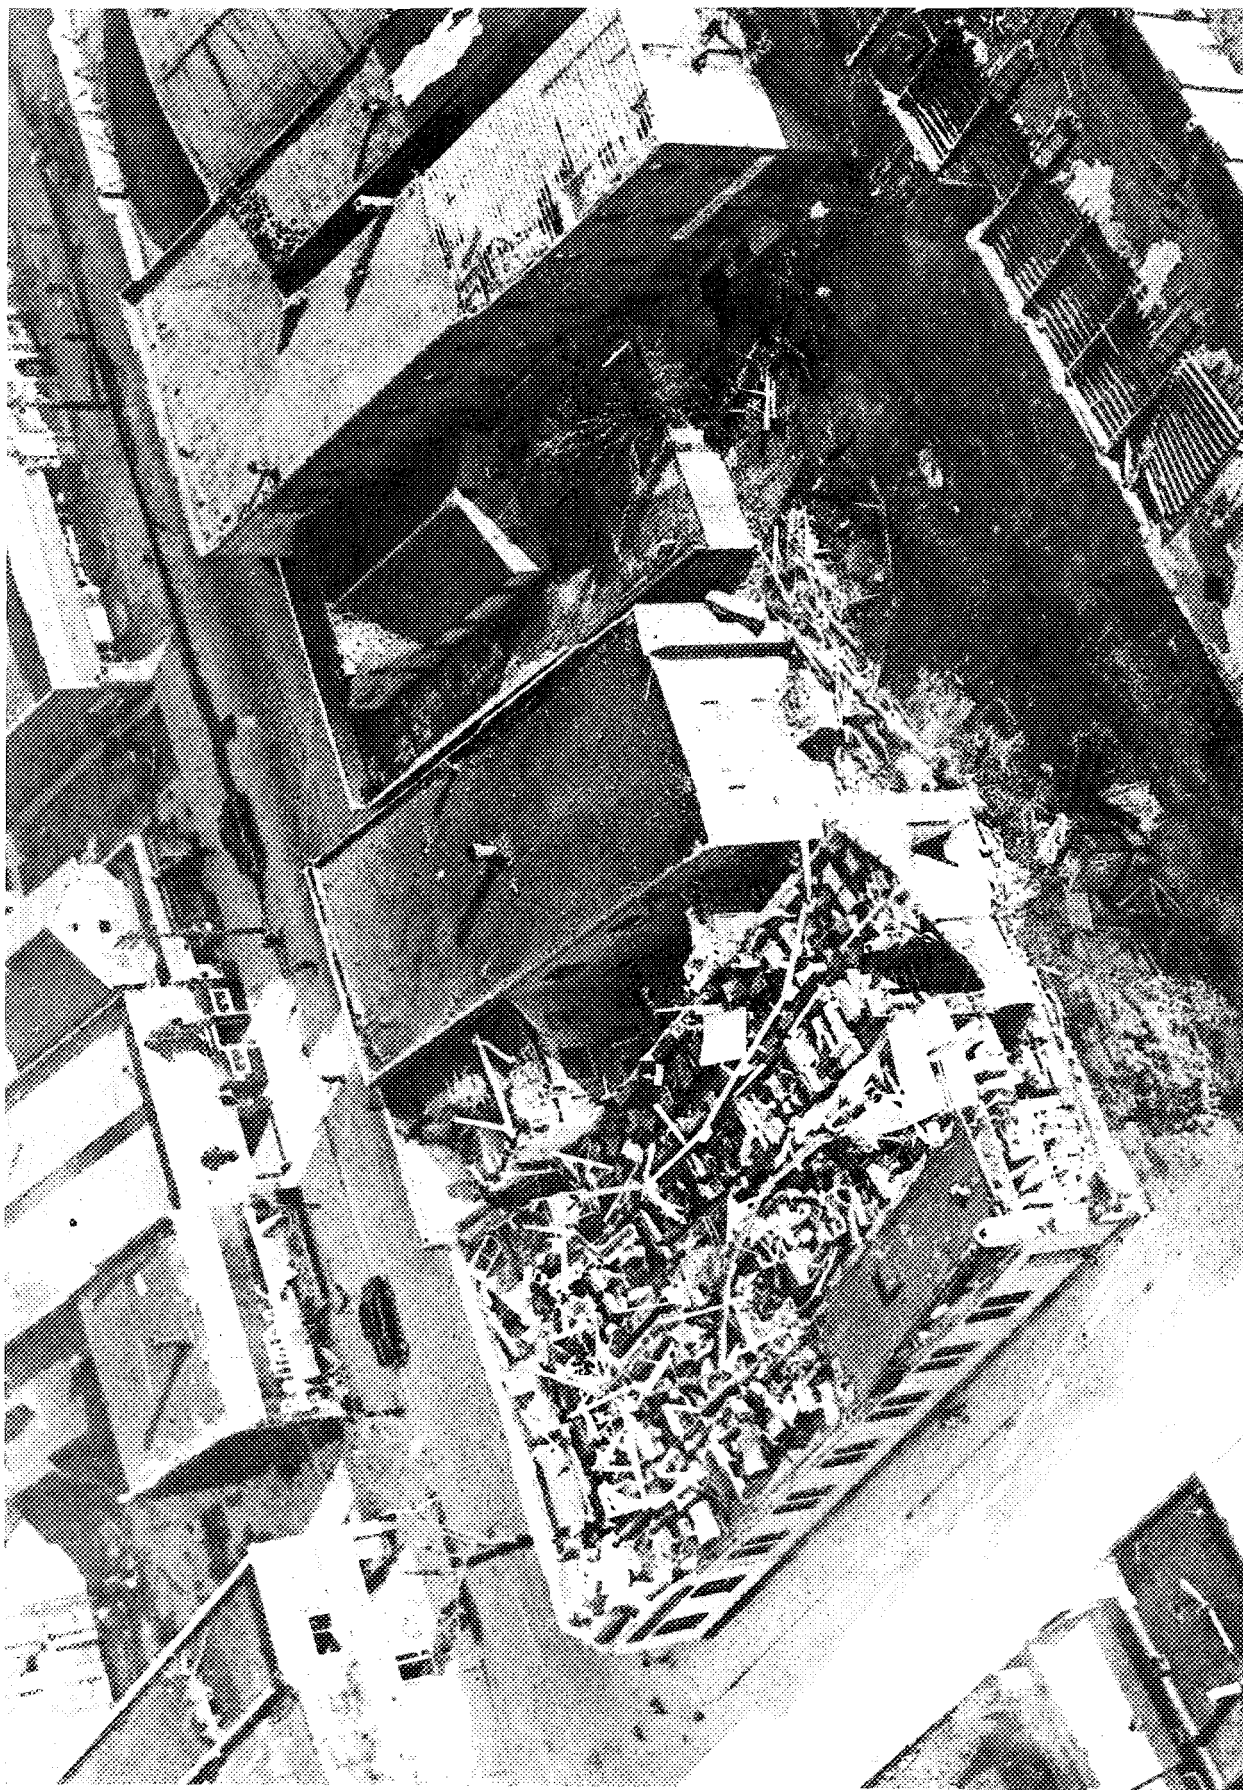
One building that received extensive damage was the two-storey building on Christina Street occupied by a bank and furniture store. The entire roof was removed together with the second-storey wall. The furniture in the second floor show-room appeared to have been relatively undisturbed, and was entirely exposed to the elements after the storm had passed (Fig.7). Water damage to the first floor was due to the second floor sprinkler system which was broken in the storm.

44. Aerial view of business block in Sarnia, including Imperial Theatre
45. Aerial view of business block showing Imperial Bank and Taylor's Furniture Store. Note extensive damage to roofs caused by low pressure and centre of storm (Fig.7 in DBR Report 111)

Photo by London Free Press
Figure 7 Aerial view of business block, showing Imperial Bank and Taylor's Furniture Store. Note extensive damage to roofs caused by low pressure and centre of storm

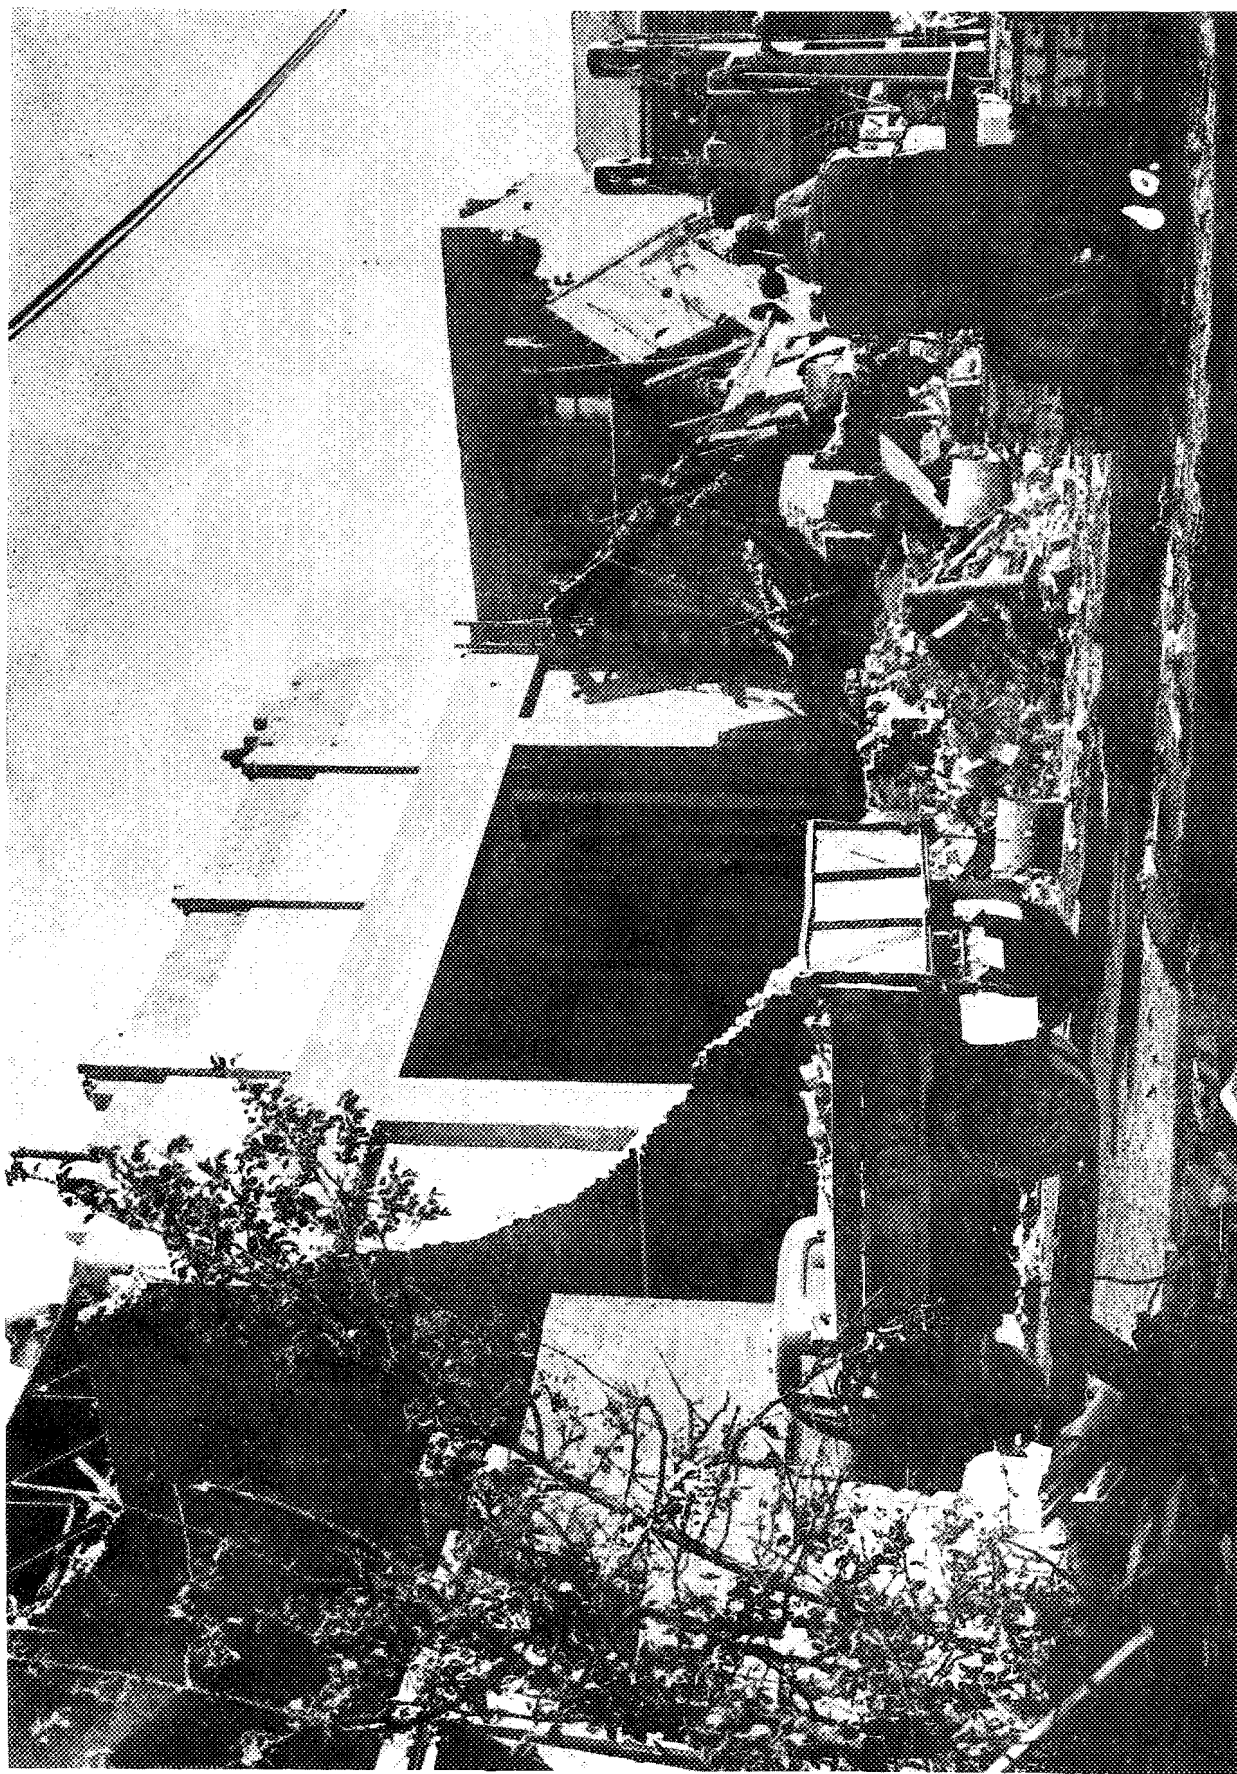
The entire stage portion of the Imperial Theatre, consisting of a large expanse of laterally unsupported masonry bearing wall, was totally demolished (Fig.8). The remainder of the building, constructed of a steel and reinforced concrete frame, was damaged only in the bays adjacent to the stage portion of the building. The damaged portion of the building was on the lee side of the approaching storm and failure probably was due to the differential of pressure between the atmospheric pressure on the inside of the building and the low pressure of the core of the vortex on the outside.

Photo by Roy Paisely, Sarnia
Figure 8 Imperial Theatre. Collapse of brick wall behind stage and part of roof.

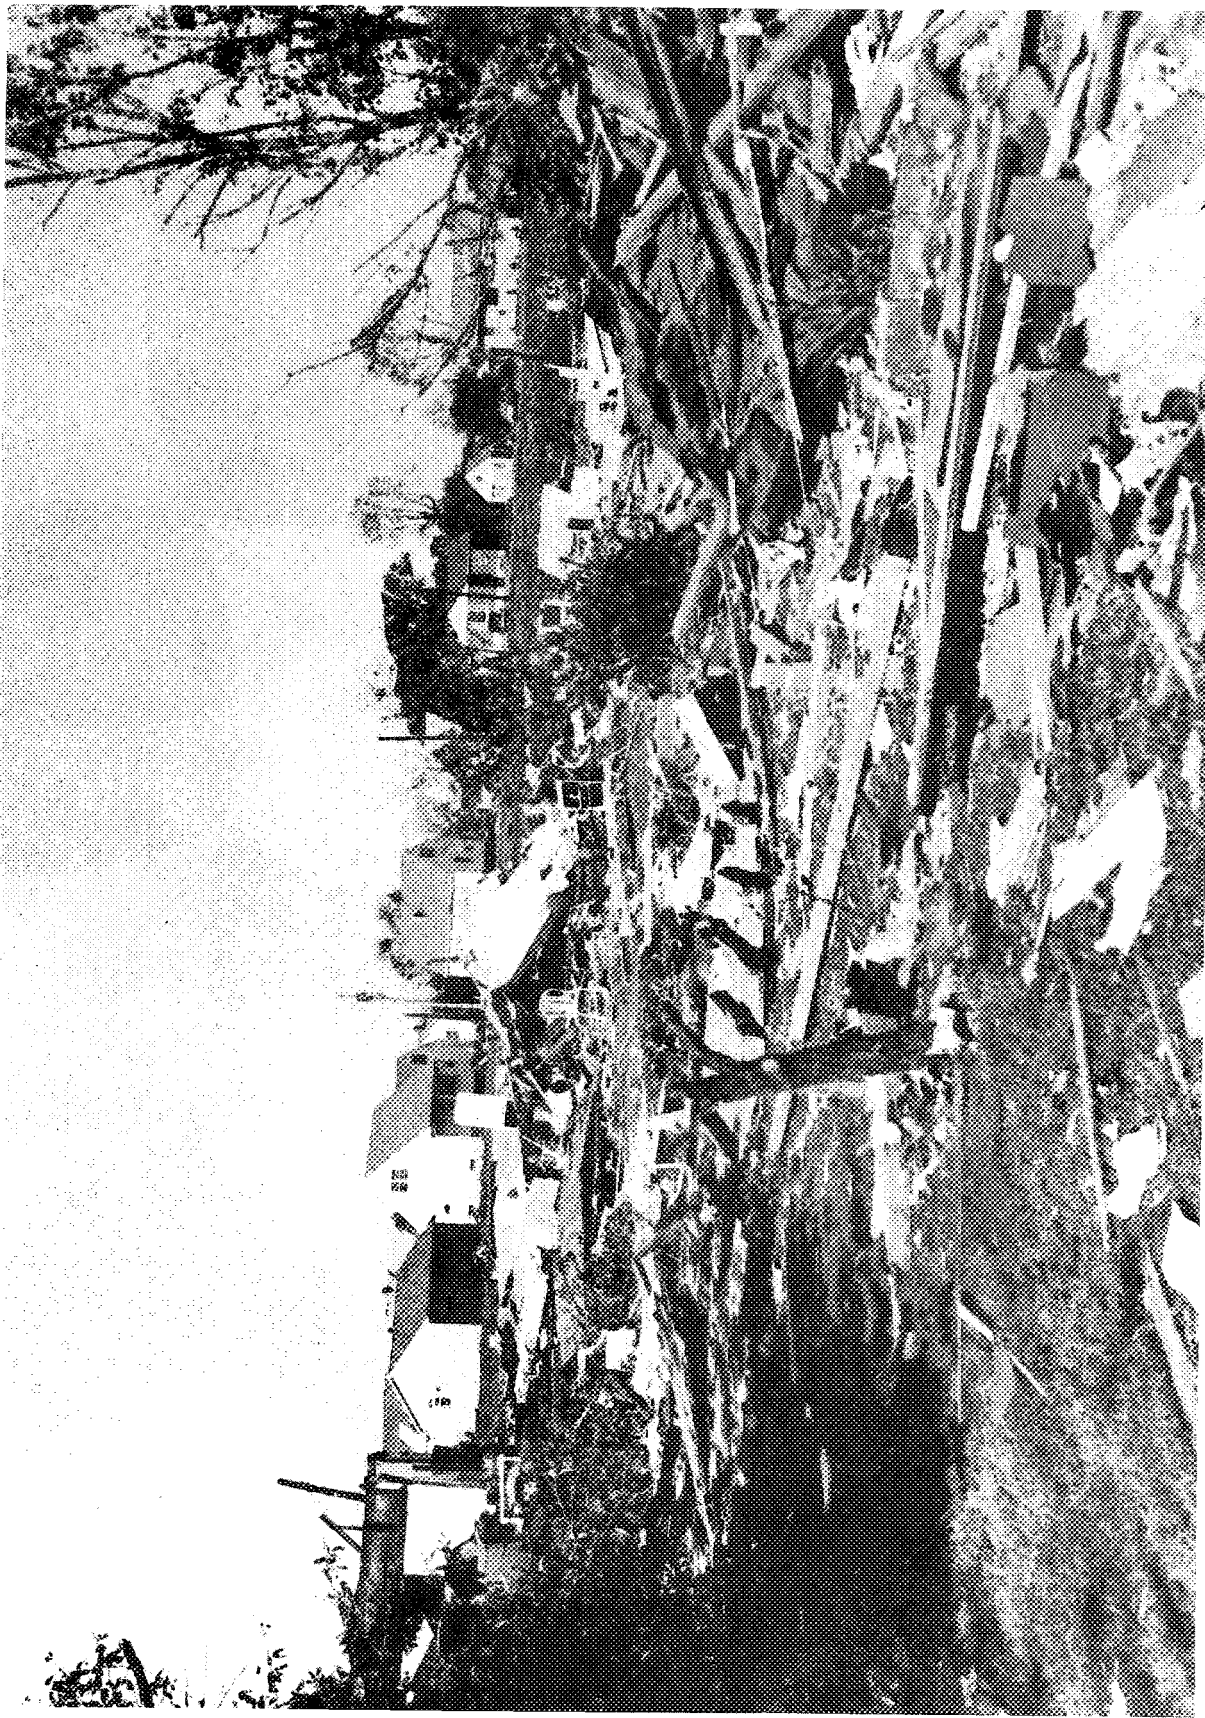
Damage to residential construction varied considerably. Some houses were entirely demolished (Fig.9); others had their roofs torn away (Fig.10); and some were moved off their foundations (Fig.11). These were the more severe results of the storm's passage. Less severe damage consisted of loss of portions of the roof or of roofing material, loss of siding, or damage from flying debris, such as parts of other buildings and falling trees.

Photo by Canadian Observer, Sarnia
Figure 9 Damage to frame houses. Note limited area of damage

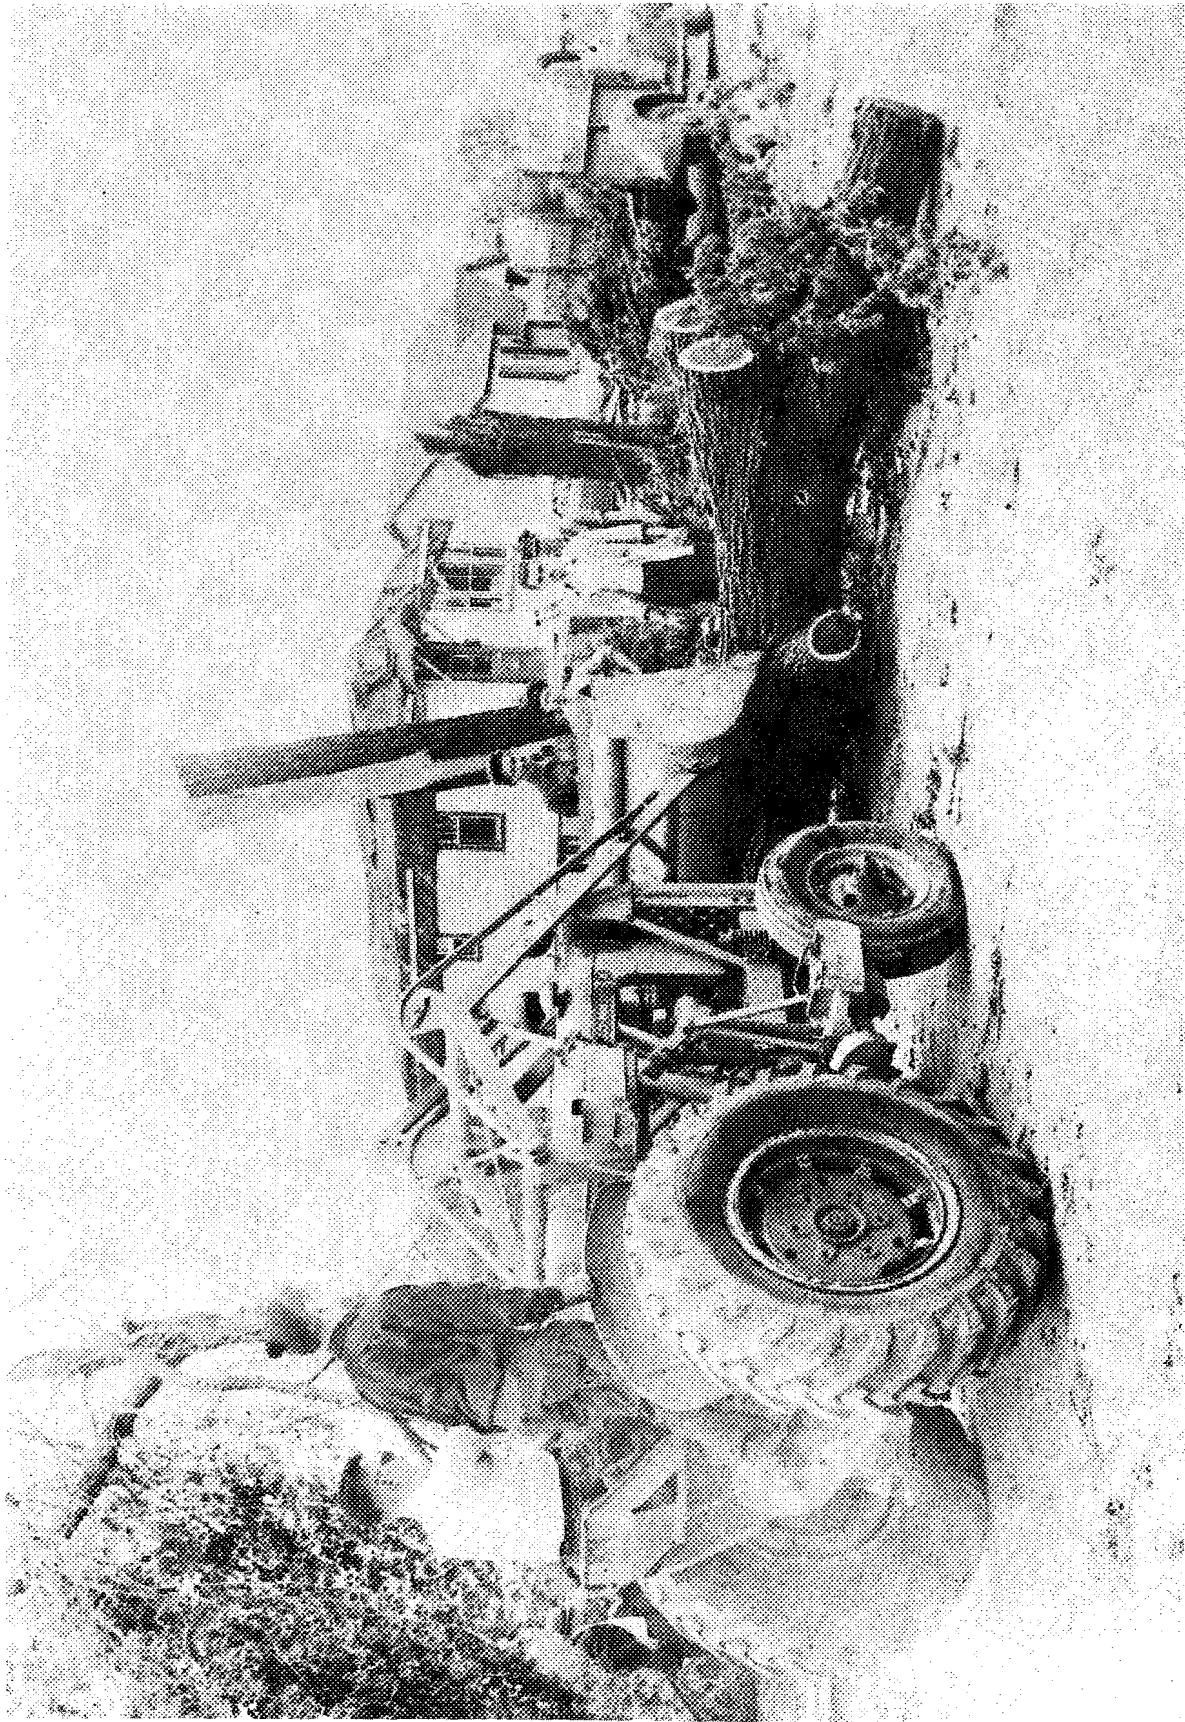
The loss of roofs and movement off foundation indicated inadequate fastening details at these points. In many of these cases adjacent houses, apparently built by different contractors,

did not receive similar damage (Fig. 10).

Photo by Canadian Observer, Sarnia
Figure 10 Tree damage. Note one house with, and one house without, roof

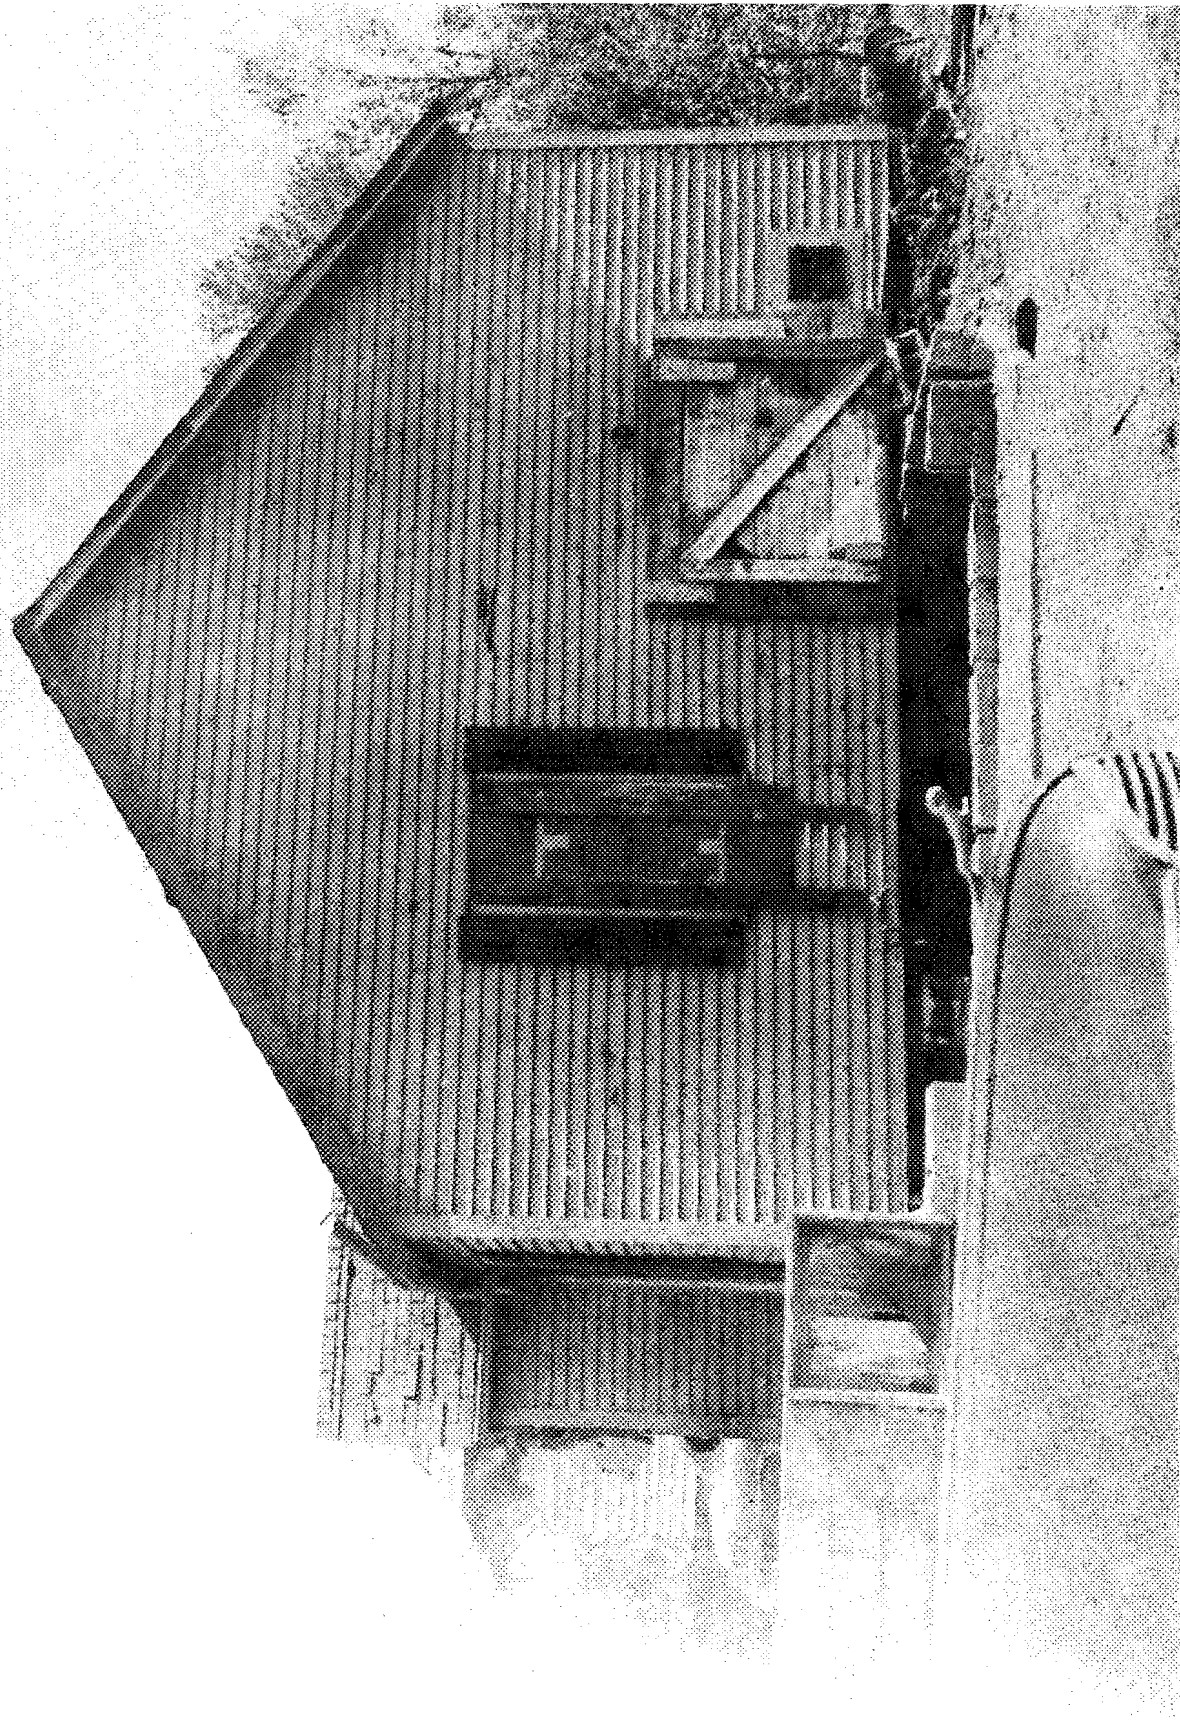
Figure 11 Frame house dislocated from foundation

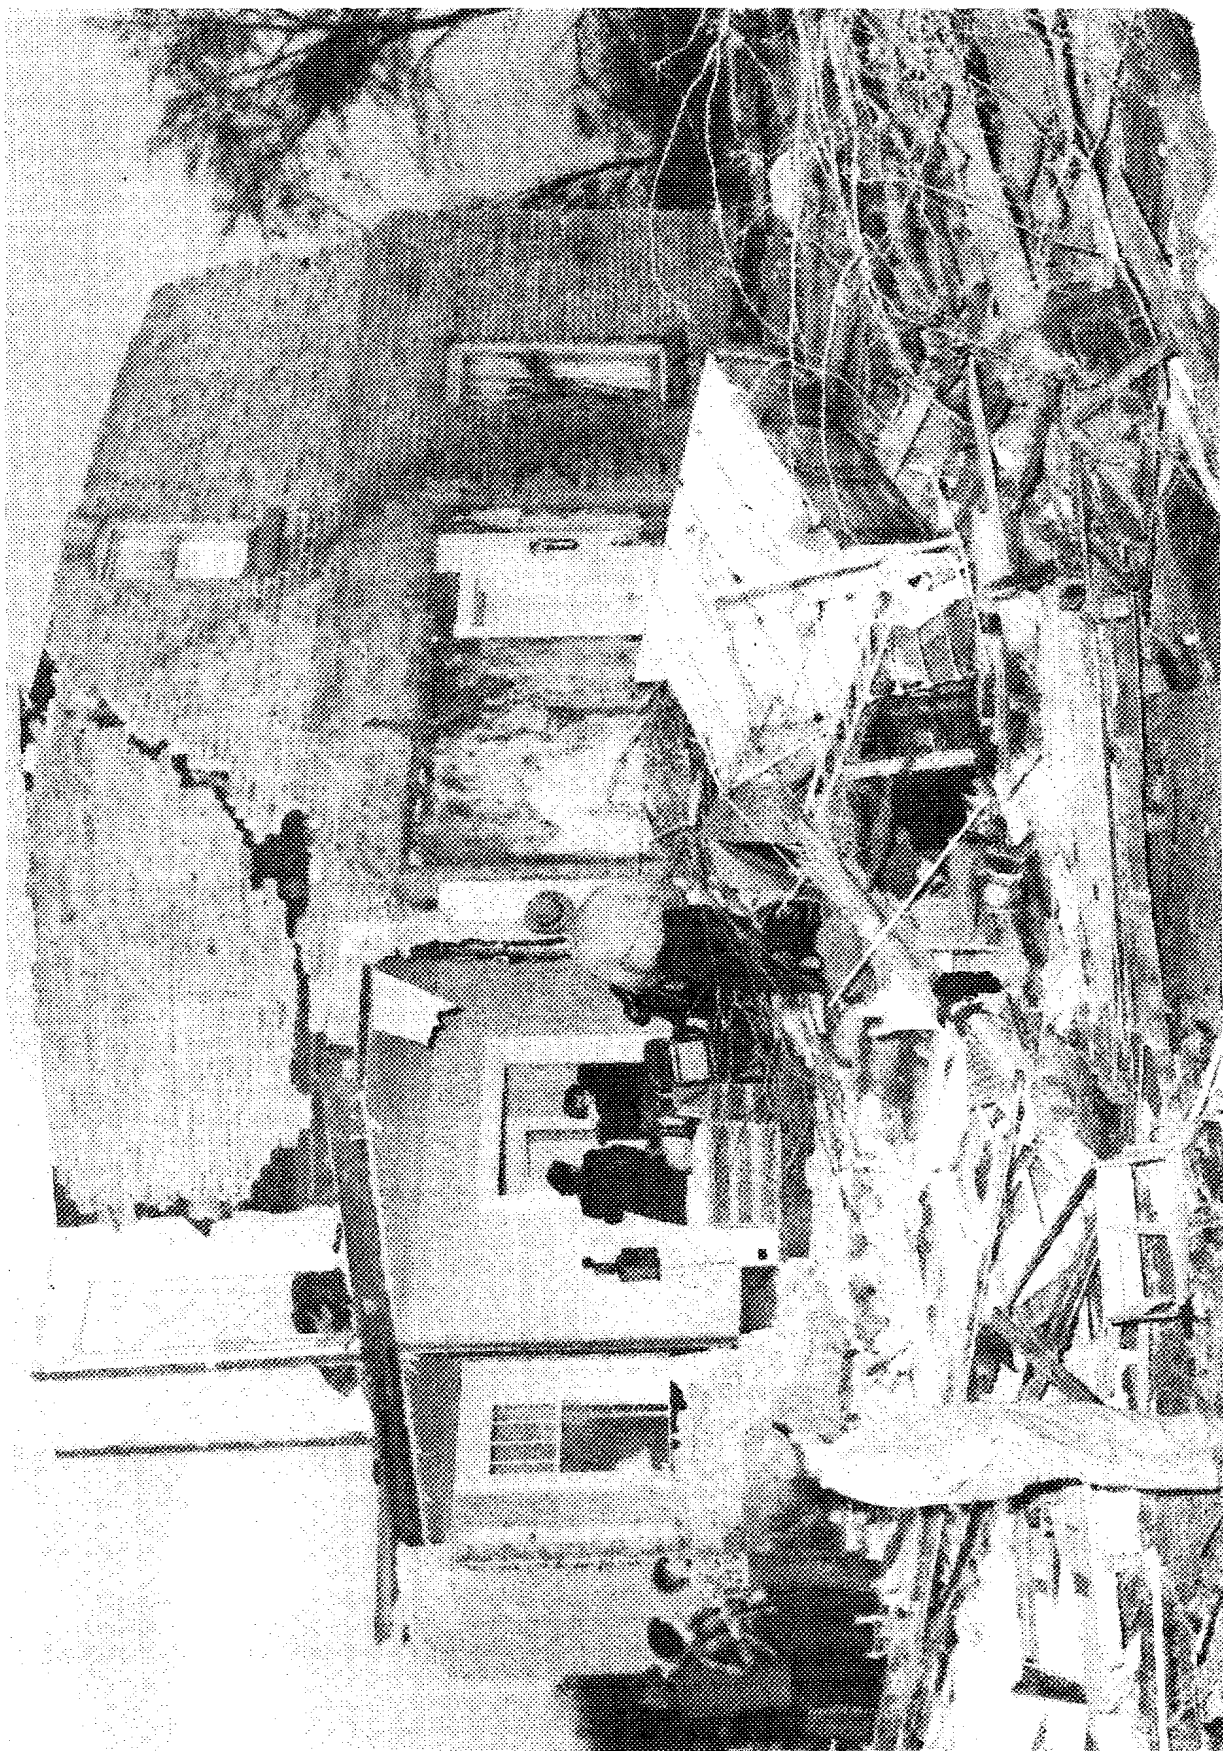
Most of the farm residences were of masonry veneer construction and generally suffered extensive damage, if not complete demolition (Fig. 12). The completeness of this damage probably was due to the fact that, in most cases, these buildings were completely exposed to the full effects of the storm.

Figure 12 Damage to farm homes
